**Stoney Creek Trail Report
No. 41 - August 2022**

Stoney Creek Water Quality Report (Part 1):

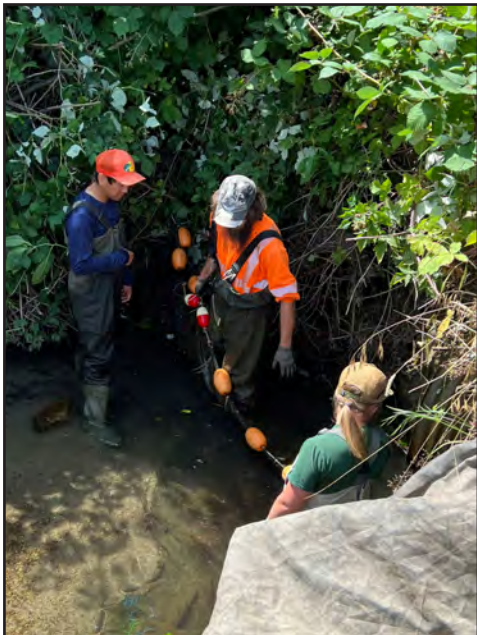
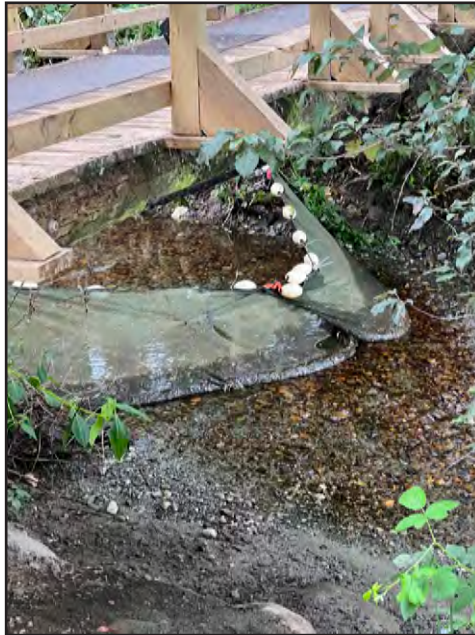
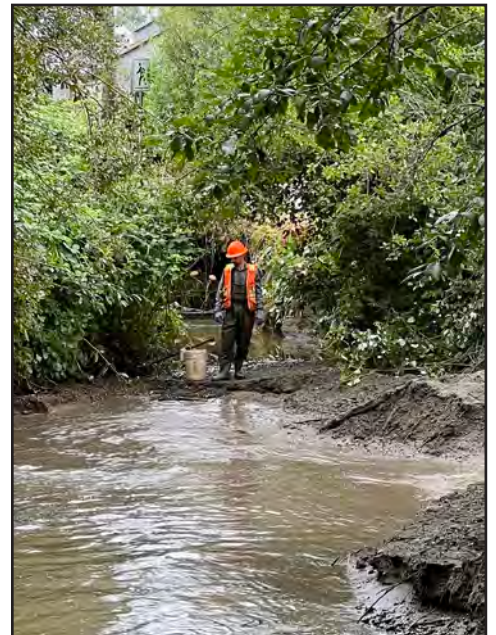
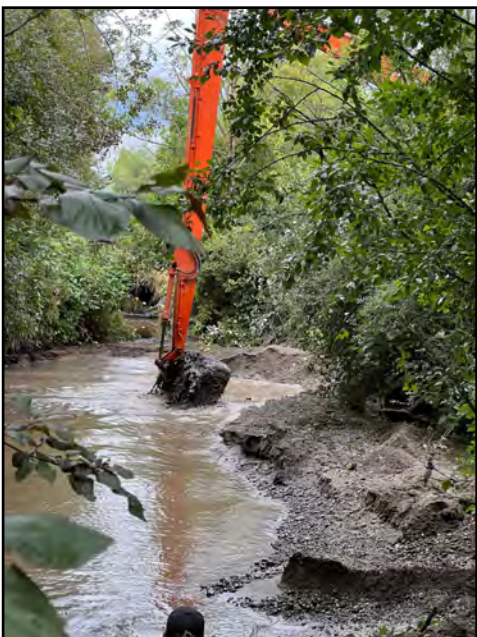
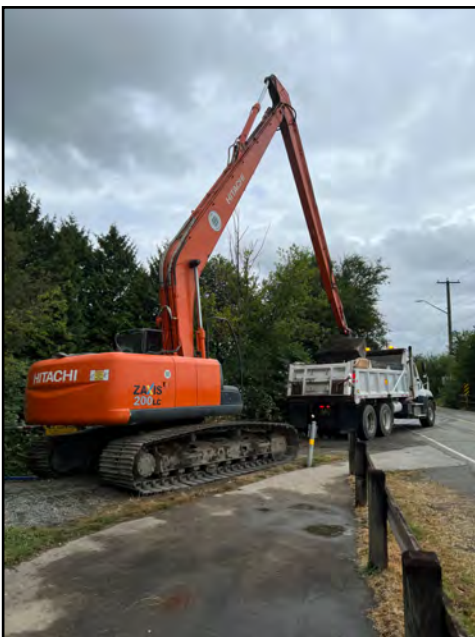
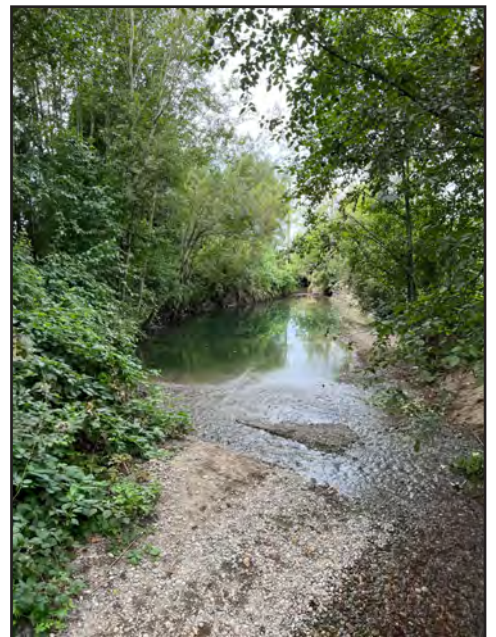
Pond Excavation:

For the second time this year, a City crew removed some of the huge quantity of gravel that had been deposited in the Pond by last November's deluge. **On the 4th**, an AquaTerra Environmental crew prepared the work area by setting up net barriers in the Creek. One was downstream, at the Bateman Road culvert. The other was upstream, under Bridge 0. Then, by "e-fishing" (electrically stunning) the salmon fry living in the pond, they were captured and moved outside the barriers, out of danger.

On the 5th, 20 truckloads of gravel were scooped out and hauled away. The clean gravel went to a nearby farmyard, while the "muck" containing leaves and silt went to the dump on Valley Road. While it was in progress, AquaTerra monitored the work, concerned with water turbidity in particular. **By the 7th**, the water had cleared sufficiently and the net barriers were removed. The Pond is now much deeper.

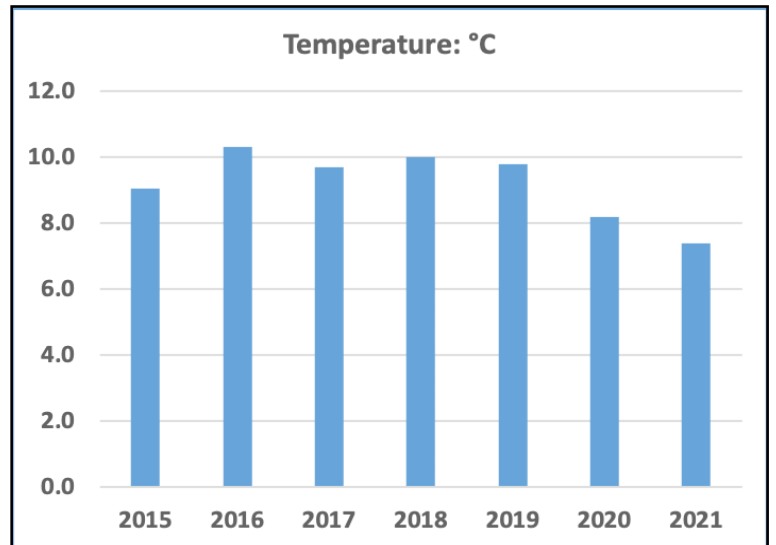
Temperature:

Water temperature is important because it can determine where certain plants and animals can live. It also influences the amount of dissolved oxygen in water. Cold water can hold more oxygen than warm water. Water temperature is influenced by water clarity. Note that **for coho fry, the optimal growth range is from 10° to 15°**.

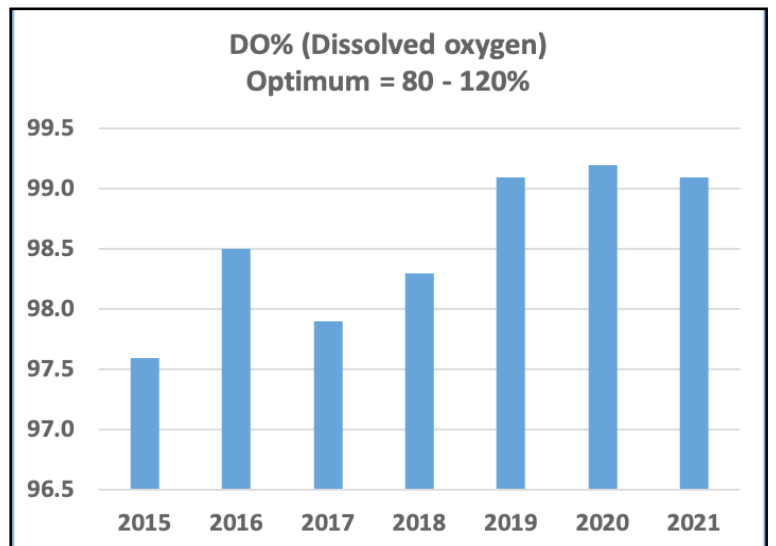
DO (Dissolved oxygen):

This is an indicator of the water's ability to support life. The burbling of water over rocks, water temperature and depth, and the number of plants such as algae will affect the oxygen content. Plants produce oxygen, while bacteria use up oxygen during decomposition of dead plants. In most cases, **Stoney Creek's levels are good**, usually near 100%.

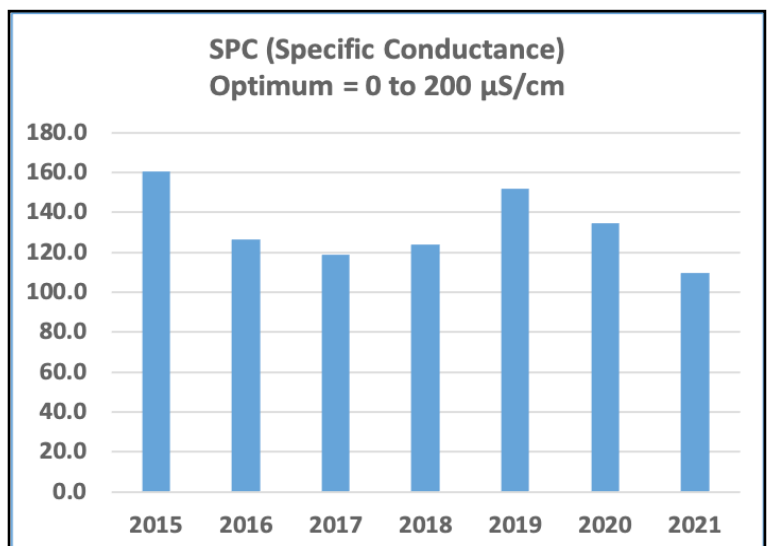
SPC (Conductivity):

This is a measure of how easily electricity flows through the water due to dissolved salts. Pure water would have zero conductivity. Conductivity would be expected to increase in summer due to less dilution from precipitation plus greater evaporation during warm temperatures. Changes in conductivity can be used as an indicator that there is some source of pollution.

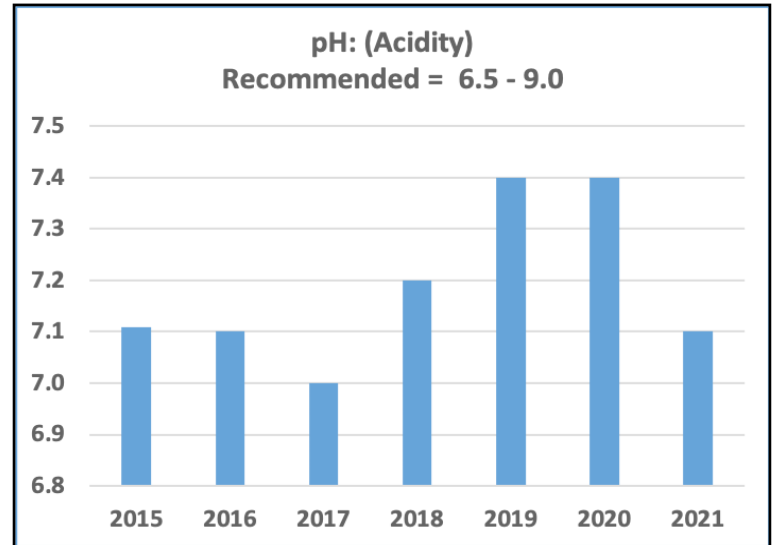
pH (acidity):

Most aquatic life functions best at a pH range of 6.5—8.5. Pure water has a pH of 7.0 (neutral). Natural causes of acidity (lower pH) can be high levels of organic compounds as well as some man-made compounds in precipitation run-off. Higher pH (alkalinity) can also come from man-made pollutants as well as dissolved minerals from bedrock and soil. **The pH level of Stoney Creek water is good.**

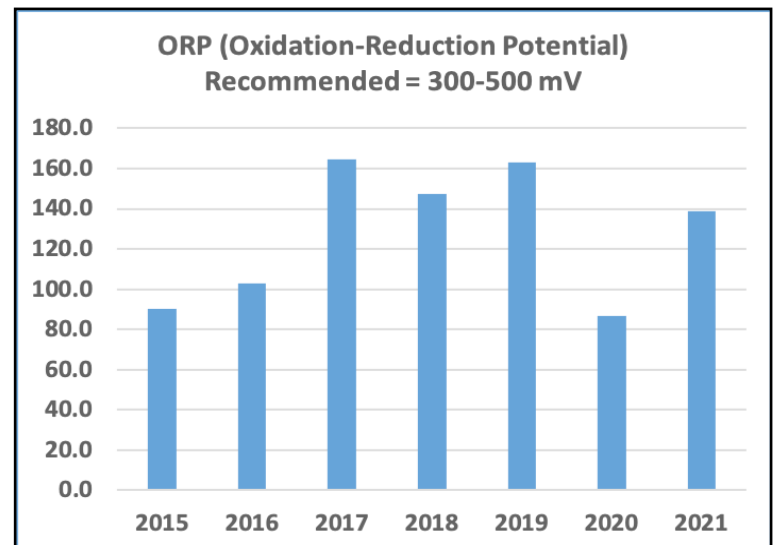
ORP (Oxidation-Reduction Potential):

ORP provides a measurement of the ability of the stream to cleanse itself by oxidizing (breaking down) contaminants coming from rainfall run-off, sewage, etc. Values around 500 mV are best, while lower values indicate impairment. **The bacteria level in Stoney Creek is a concern**, particularly in warm weather.

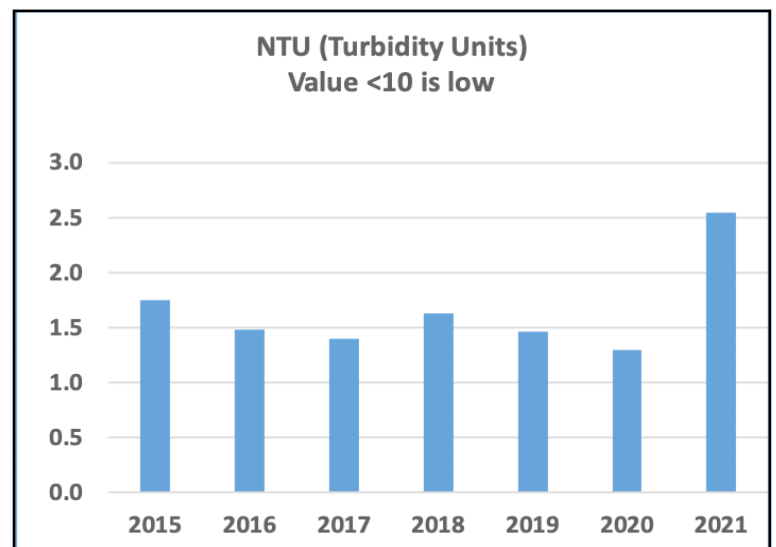
NTU (Turbidity):

Turbidity is a measure of water clarity. It indicates the amount of light scattered or blocked by particles suspended in the water. More particles will absorb more sunlight, increasing water temperature. They will decrease the penetration of sunlight into the depths of the water, decreasing photosynthesis (oxygen production) by aquatic plants.

Turbidity values less than 10 NTU are considered low, 50 NTU would be considered moderate, and very high turbidity values can be more than 100 NTU. The graph shows that **Stoney Creek water normally has low turbidity.**

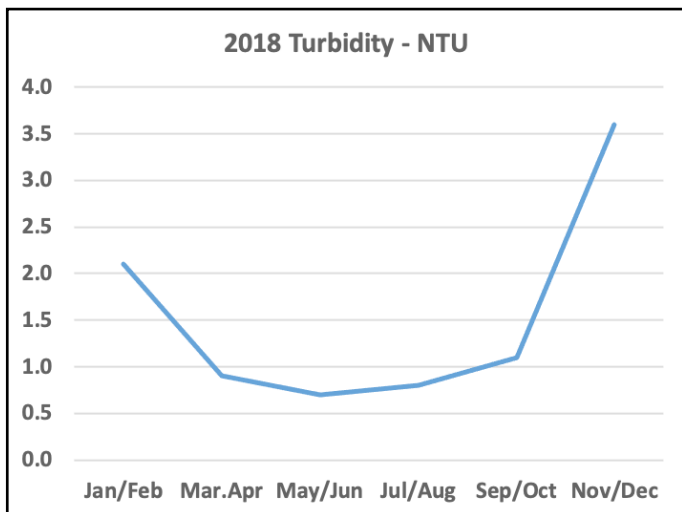
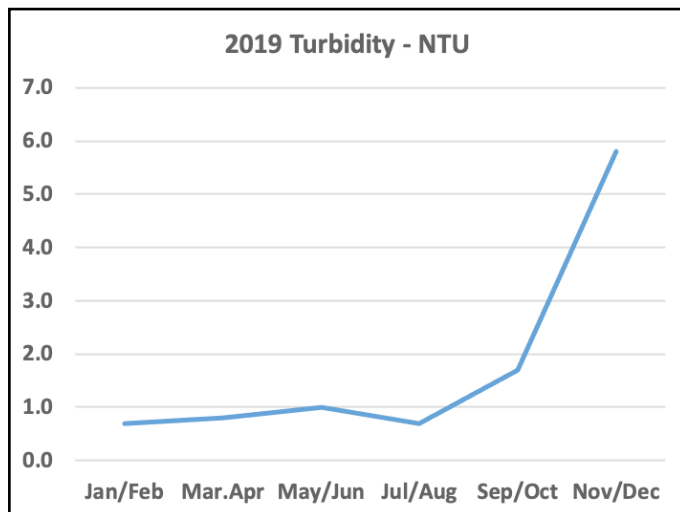
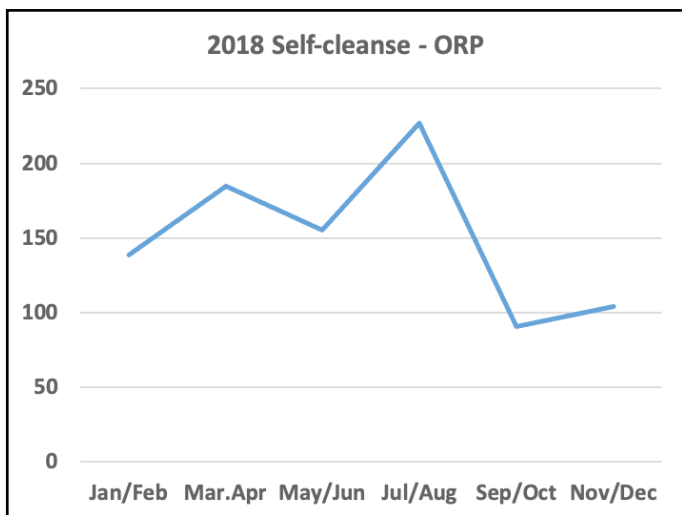
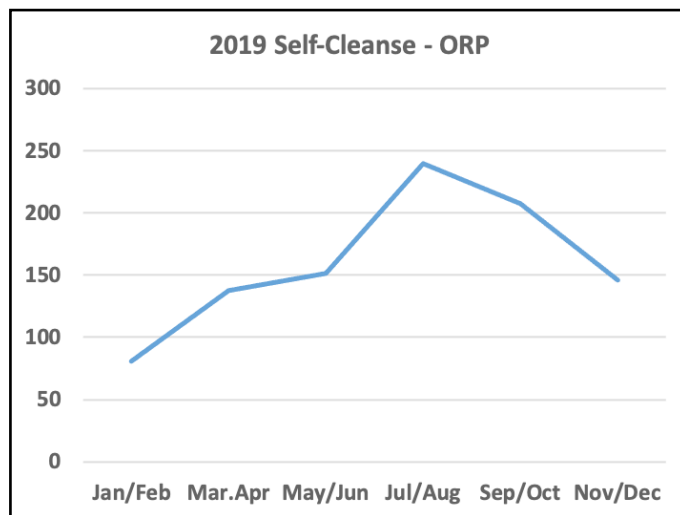
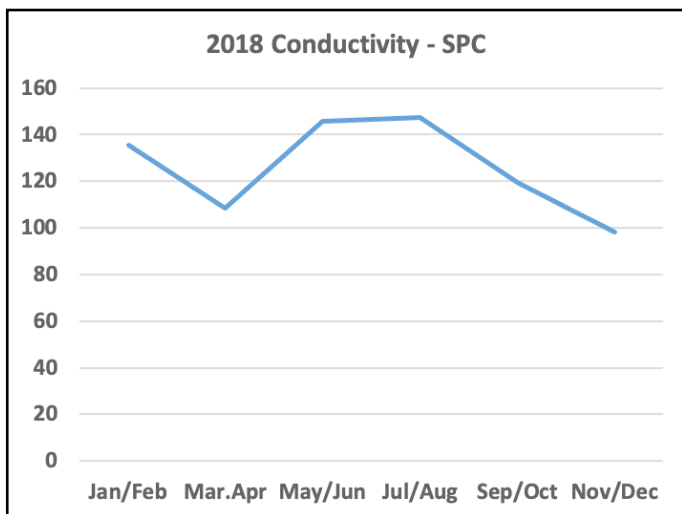
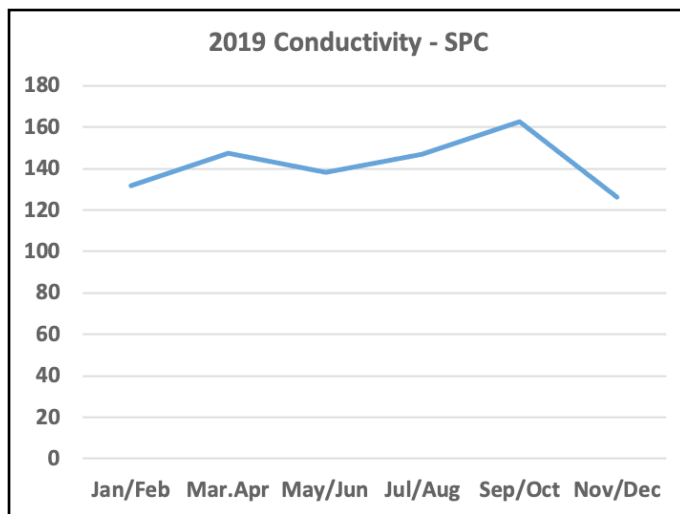
Stoney Creek Water Quality Report (Part 2):

Water sampling began in 2015, but the frequency has varied widely due in part to the COVID-19 pandemic (47 tests were carried out in 2018, 45 in 2019, but only 22 in 2020 and 11 in 2021). These graphs display bimonthly averages and are meant to show that **values vary with the seasons** (warm vs. cold; dry vs. wet). Fall and winter precipitation events greatly affect turbidity (NTU) and salinity (SPC).
