**Stoney Creek Trail Report
No. 54 - September 2023**

The Bridge 6 Project (1/5)

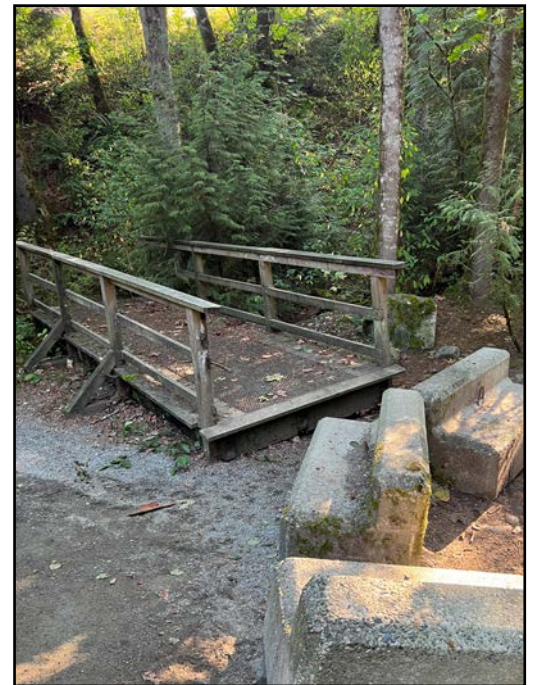
Old Bridge 6

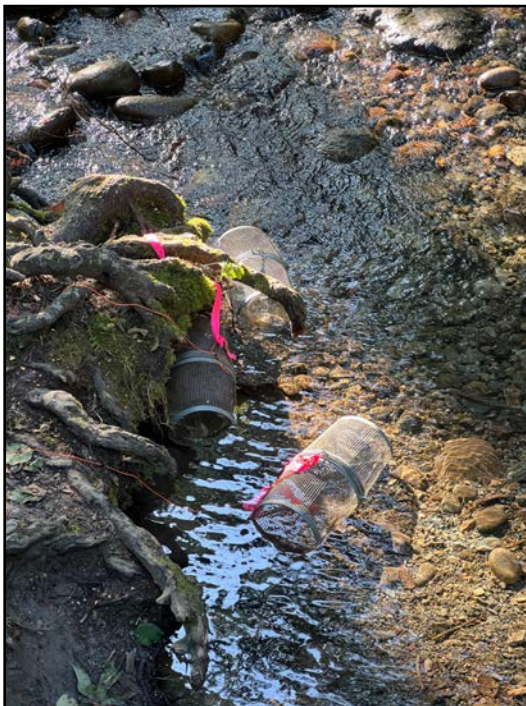
Bated minnow traps

“Fish collection techniques included 3 consecutive days of ‘minnow’ trapping as well as electrofishing and dip netting. Minnow traps were baited and placed within the fish exclusion fencing for 24 hours. Any fish captured are released downstream of the exclusion area. We relocated approximately 200 fish from the workspace (it’s a very good habitat for coho and trout). Electrofishing was conducted following removal of the minnow traps to capture any fish remaining within the exclusion area.

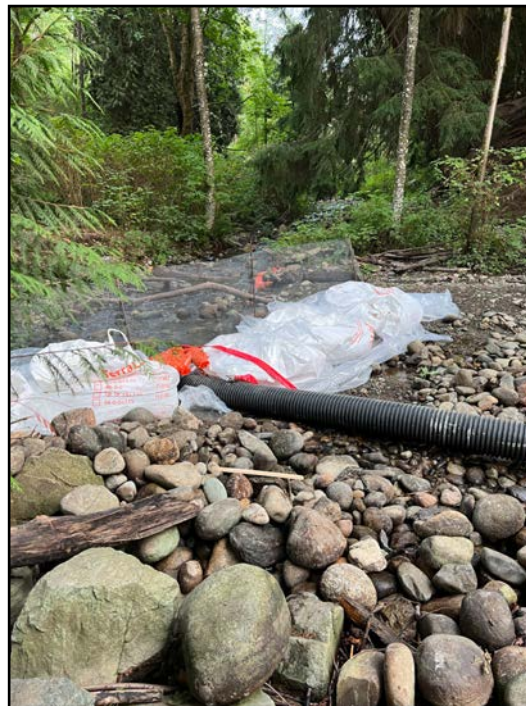
The fish exclusion barrier

The first stage of construction began on Sept. 8th when **Redcedar Environmental** installed the fish barrier, trapped and removed the fish, and diverted the Creek water through a pipe.

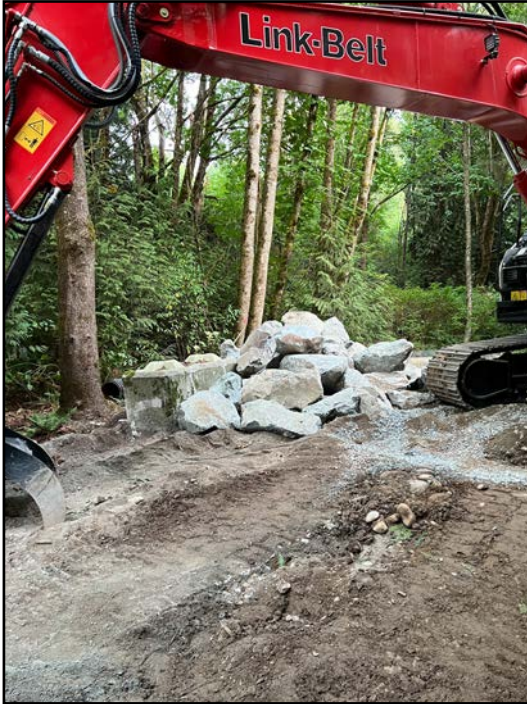
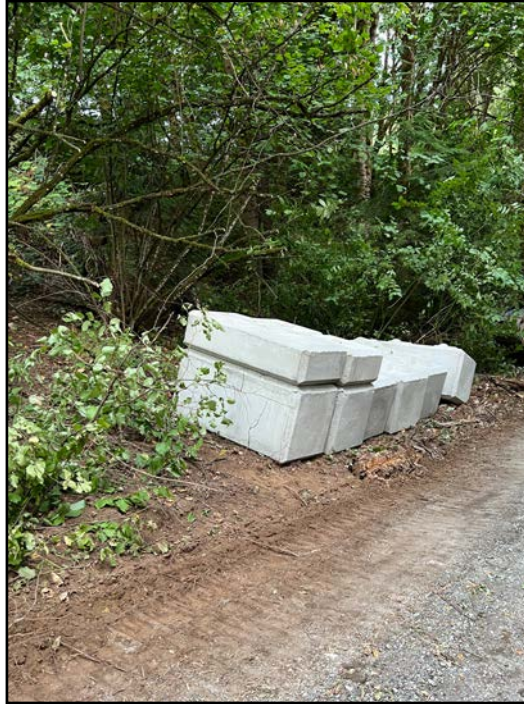
The supply of riprap boulders and concrete lock blocks

On Sept. 11th, the environmentally sensitive part of the job began: the installation of the abutments. These were constructed of 4200 lb. concrete lock blocks protected by riprap boulders, courtesy of **GeoWest Engineering** and **GDM Construction**.

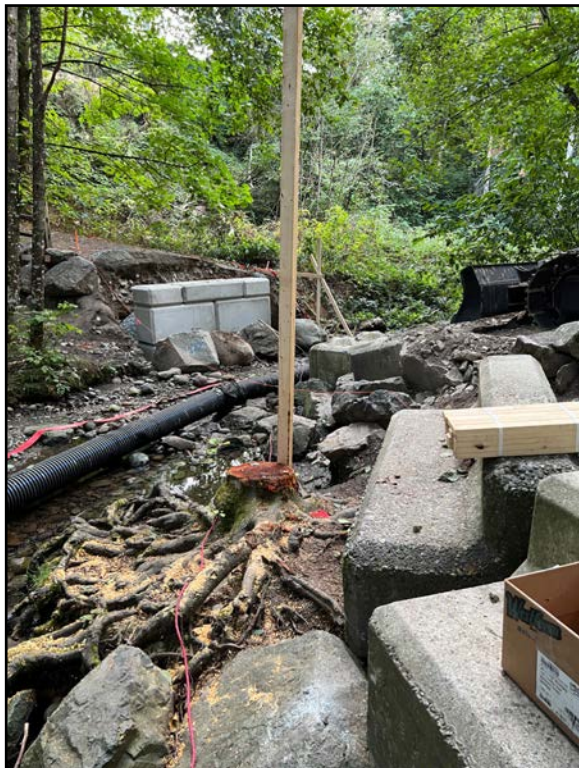
The water diversion pipe

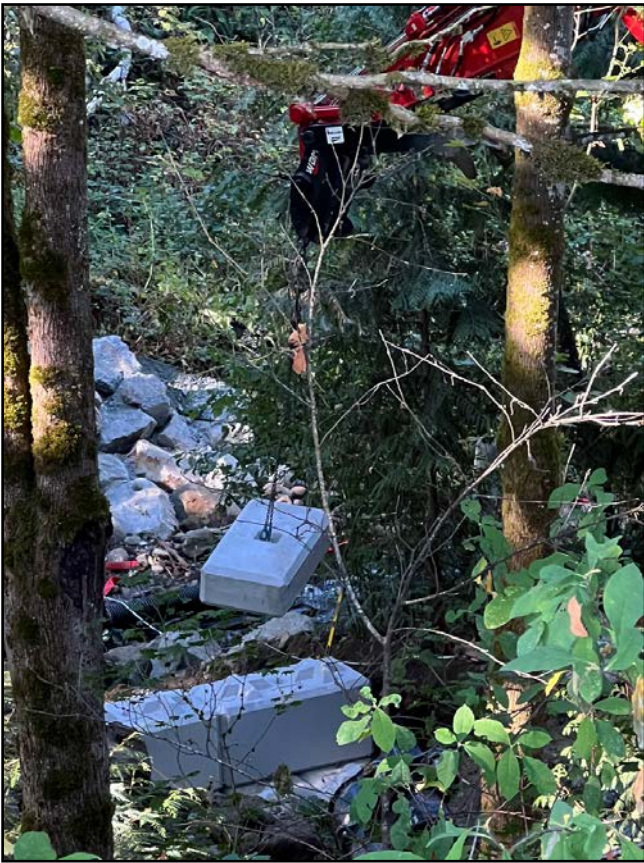
Lowering a cap block into place

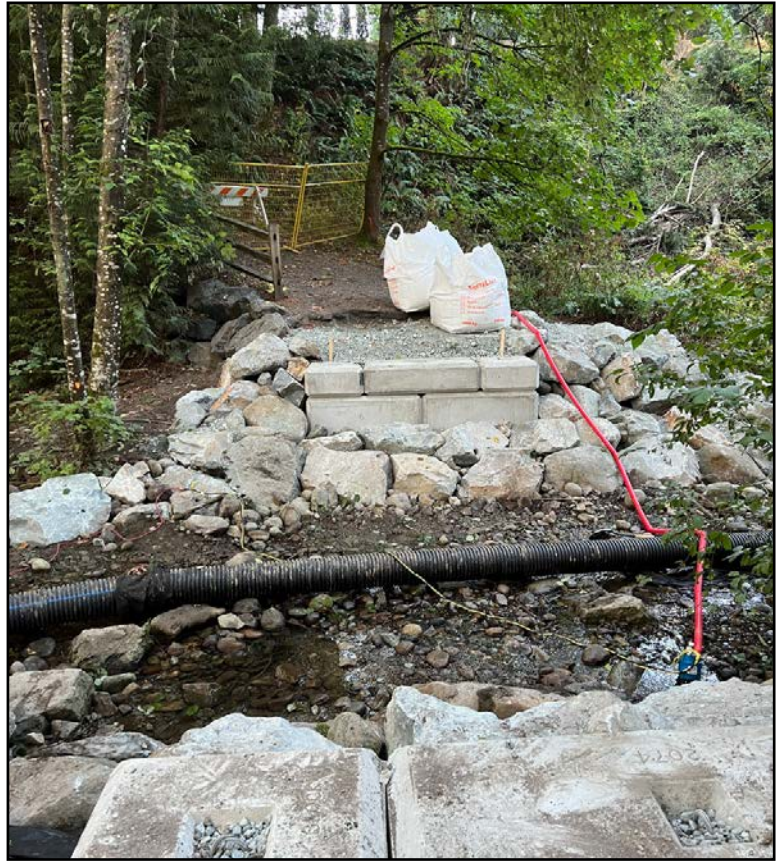
The abutments and riprap are ready

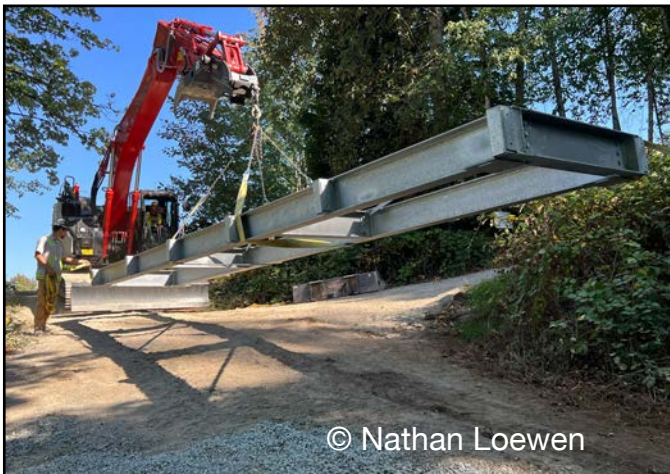
Delivering the steel bridge frame

GDM completed that part of the job by Sept. 15th, meeting the deadline set by the DFO. The fish exclusion apparatus was subsequently removed. Later that day came the installation of the 4000 lb. steel frame of the bridge designed by **ISL Engineering**.

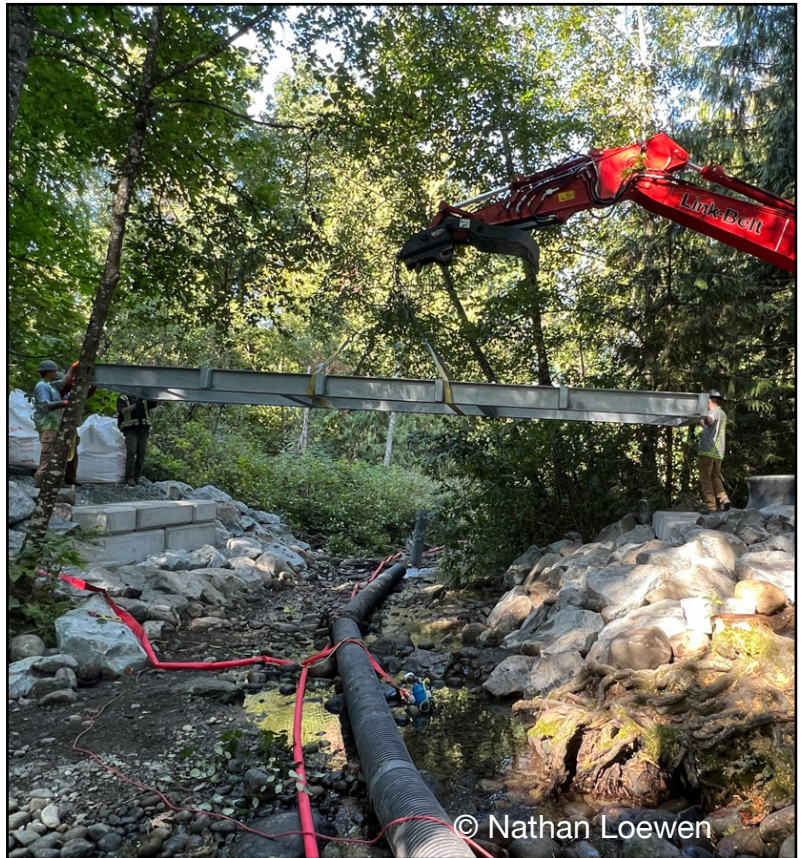
Lowering the frame onto the abutments

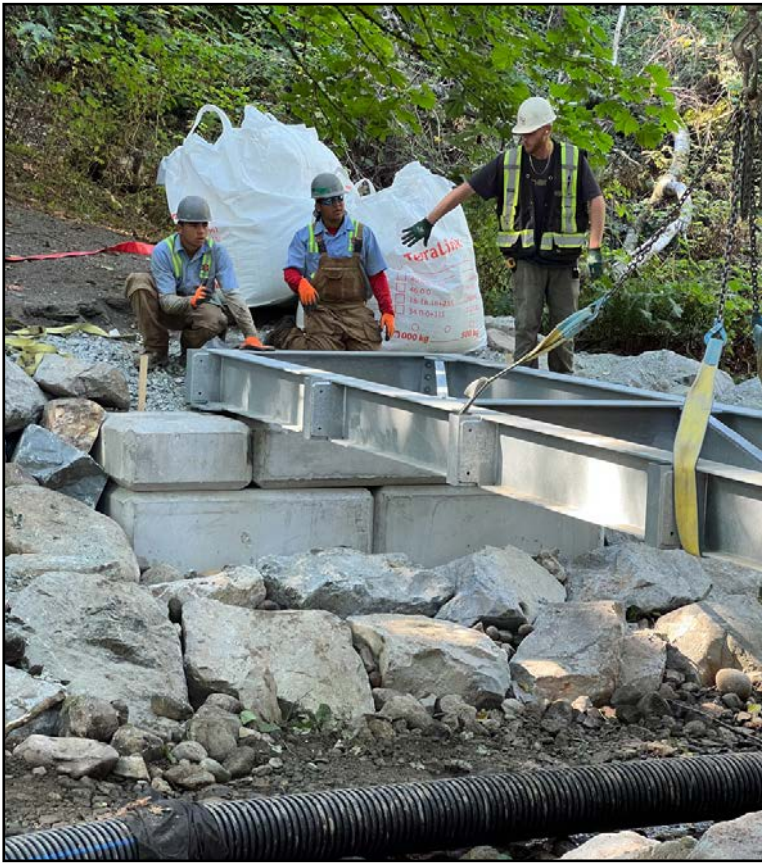
Placing the frame precisely

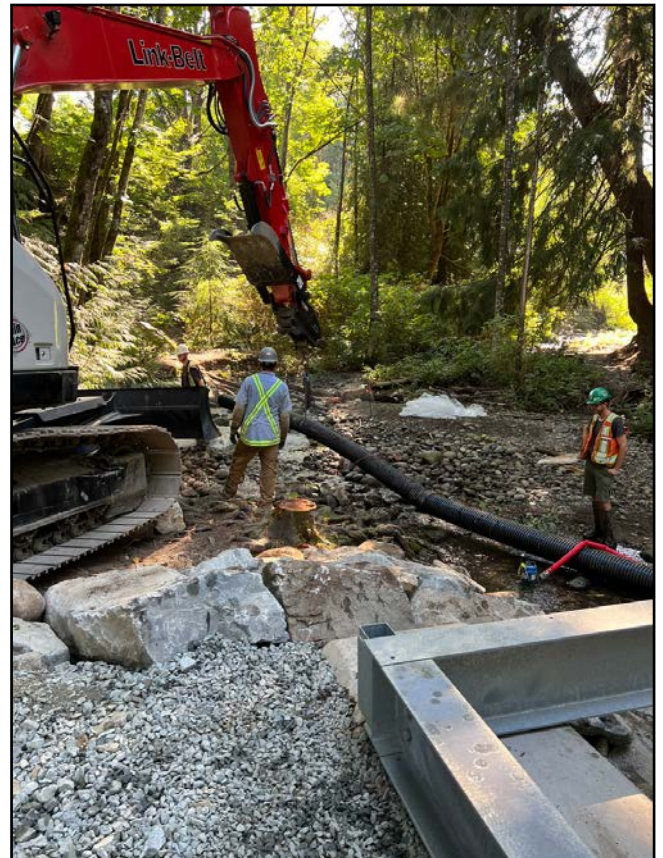
Removing the water diversion pipe
